# Design Strategies of Dwelling Health Problems Related to Dampness in Cold Climatic Regions of Japan

In order to recognize these problems, twenty-four residential buildings were measured during the rainy season of 2003. This paper describes the measurement results of mold and dust mites related to moisture problems of residential buildings, from the viewpoint of the relationship between occupant health problems and moisture environment.

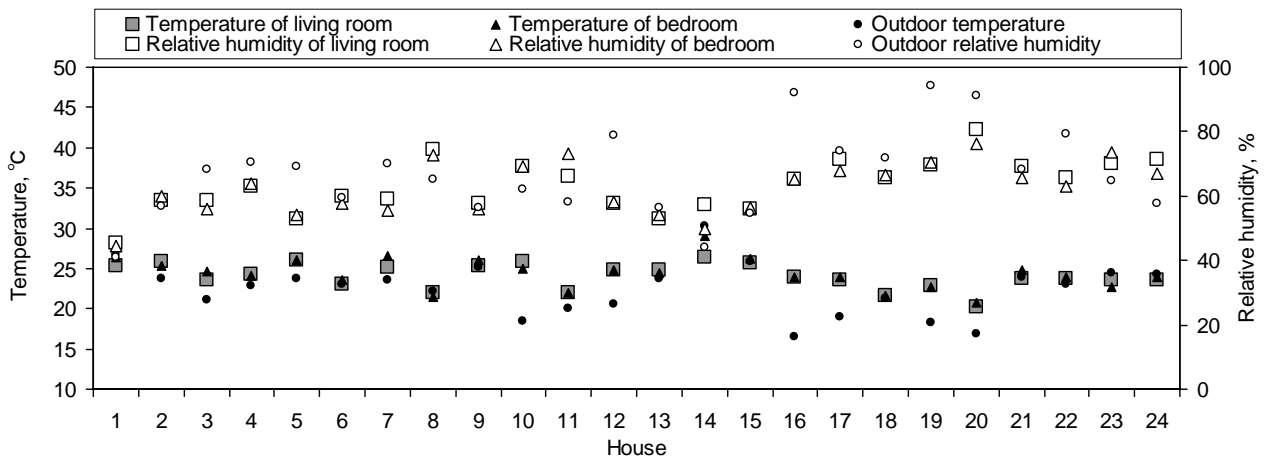
Figure 1: Indoor temperature and relative humidity averaged for visiting time

Figure 1 shows the temperature and relative humidity of the measured houses averaged for visiting time. The indoor relative humidity of most houses ranged from 50% to 70%.

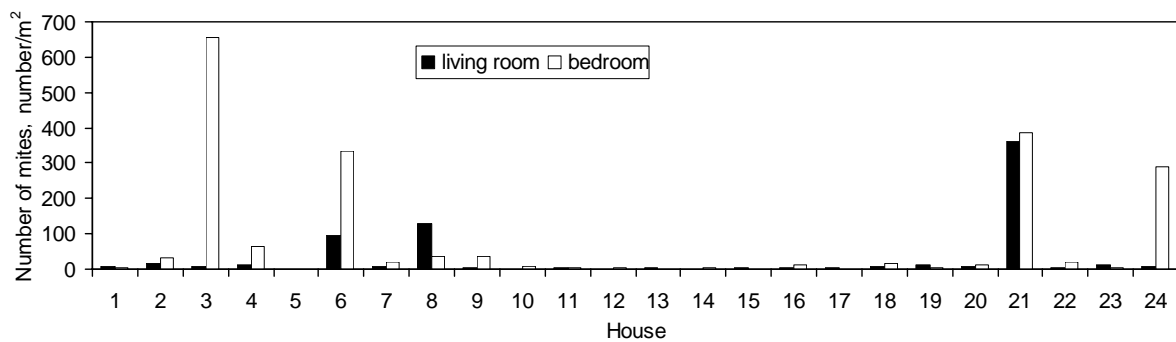
Figure 2: Number of mites in each room

Figure 2 shows the results for the number of mites in the living room and bedroom. Houses 3, 6, 8, 21 and 24 contained large numbers of mites. The occupants of House 21 preferred sweeping to vacuuming, and the occupants of House 24 had not cleaned the living room or bedroom for several days. These results appear to indicate a correlation between the number of mites and the behavior of occupants with respect to house cleaning habits.

The number of mites present in Houses 6 and 21 were larger than in other houses, as shown in Figure 2. The occupants of House 6 reported that one child was suffering from an allergy to a particular plant. In addition, the concentration of airborne fungi in House 6 was high. The child's health problem may have been caused by indoor air pollution due to the growth of mold and the presence of mites. The occupants of House 21 reported that they preferred sweeping to vacuuming and rarely cleaned using a vacuum cleaner. The large number of mites may be related to occupant behavior with respect to cleaning habits. The occupants of House 21 reported that the wife was suffering from bronchial asthma, one child was suffering from atopic rhinitis, and an elder occupant was suffering from allergies, suggesting a correlation between occupant health and indoor air pollution.

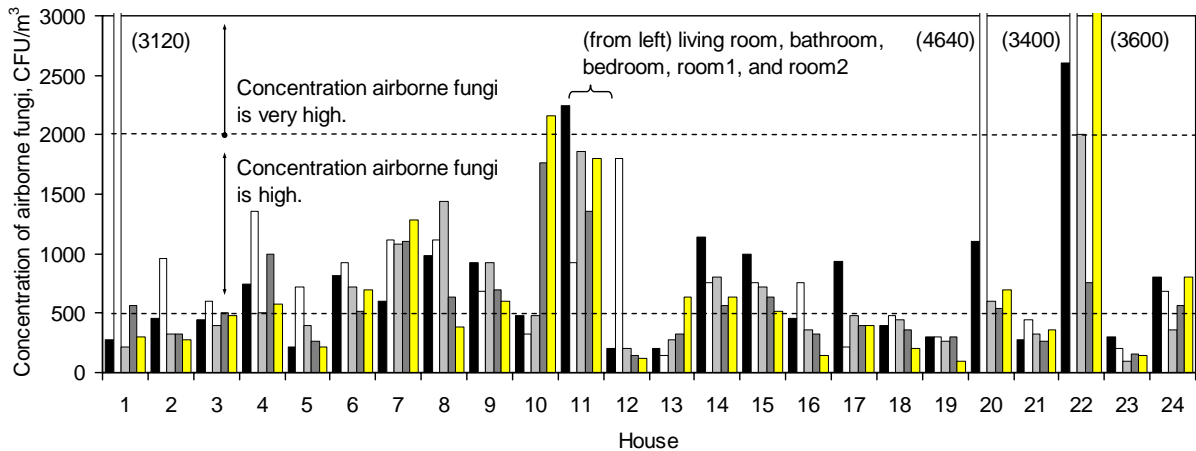
Figure 3: Concentration of airborne fungi in each room

Figure 3 shows the concentration of airborne fungi. The standard value measured by the method in this investigation should be generally 200 CFU/m<sup>3</sup>. The concentration of airborne fungi in all of the investigated houses was higher than that value. The guideline indicated in this figure has been discussed in committee among European microbiology researchers, and is used as a temporary standard. In most of the houses, the concentration of airborne fungi ranged from 500 to 2000 CFU/m<sup>3</sup>, which indicates the presence of numerous fungal spores in the indoor air.

House 1 had been repaired several years ago in order to improve the thermal environment, but no mechanical ventilation system was equipped. Therefore, airborne moisture could not be exhausted effectively. Occupants of this house complained of vapor condensation on glass surfaces during the winter and the growth of mold on wall surfaces. Mold growth was observed in a bedroom and in Room 1 both. In addition, one of the occupants of this house, a child was suffering from atopic dermatitis. During the rainy season investigation, the concentration of airborne fungi in Room 1, a child's room, was high but the number of mites was relatively low, suggesting the possibility of a correlation between occupant health problems and the concentration of airborne fungi. As shown in Figure 3, the concentration of airborne fungi in each

room of House 11 was high, and occupants reported that one child was suffering from allergies. Occupants of Houses 20 and 23, which were of reinforced concrete construction, reported the growth of mold on the floor (*tatami* mat) surface during the rainy season of the first year after moving into the house. Moisture contained in the concrete may have diffused into the houses, thus increasing the indoor humidity. In House 20, although mold growth was not observed during the investigation, the concentration of airborne fungi was high. In House 23, vapor condensation on the glass surfaces of windows caused mold growth on the wooden window frame and wall surface. The occupants of Houses 20 and 23 reported that a number of the occupant were suffering from health problems related to allergies, indicating that occupant health problems may be affected by the concentration of airborne fungi related to dampness in buildings.
